Peri-Implant Mucositis and Peri-Implantitis: A Current Understanding of Their Diagnosis, Clinical Implications, and a Report of Treatment Using a Combined Therapy Approach

The purpose of the present case report was to clinically and radiographically evaluate the use of a titanium brush and antimicrobial photodynamic therapy (aPDT) to decontaminate the implant surface, in association with regenerative procedures by means of autologous bone and demineralized bovine bone mineral (DBBM) in the treatment of peri-implantitis defects.

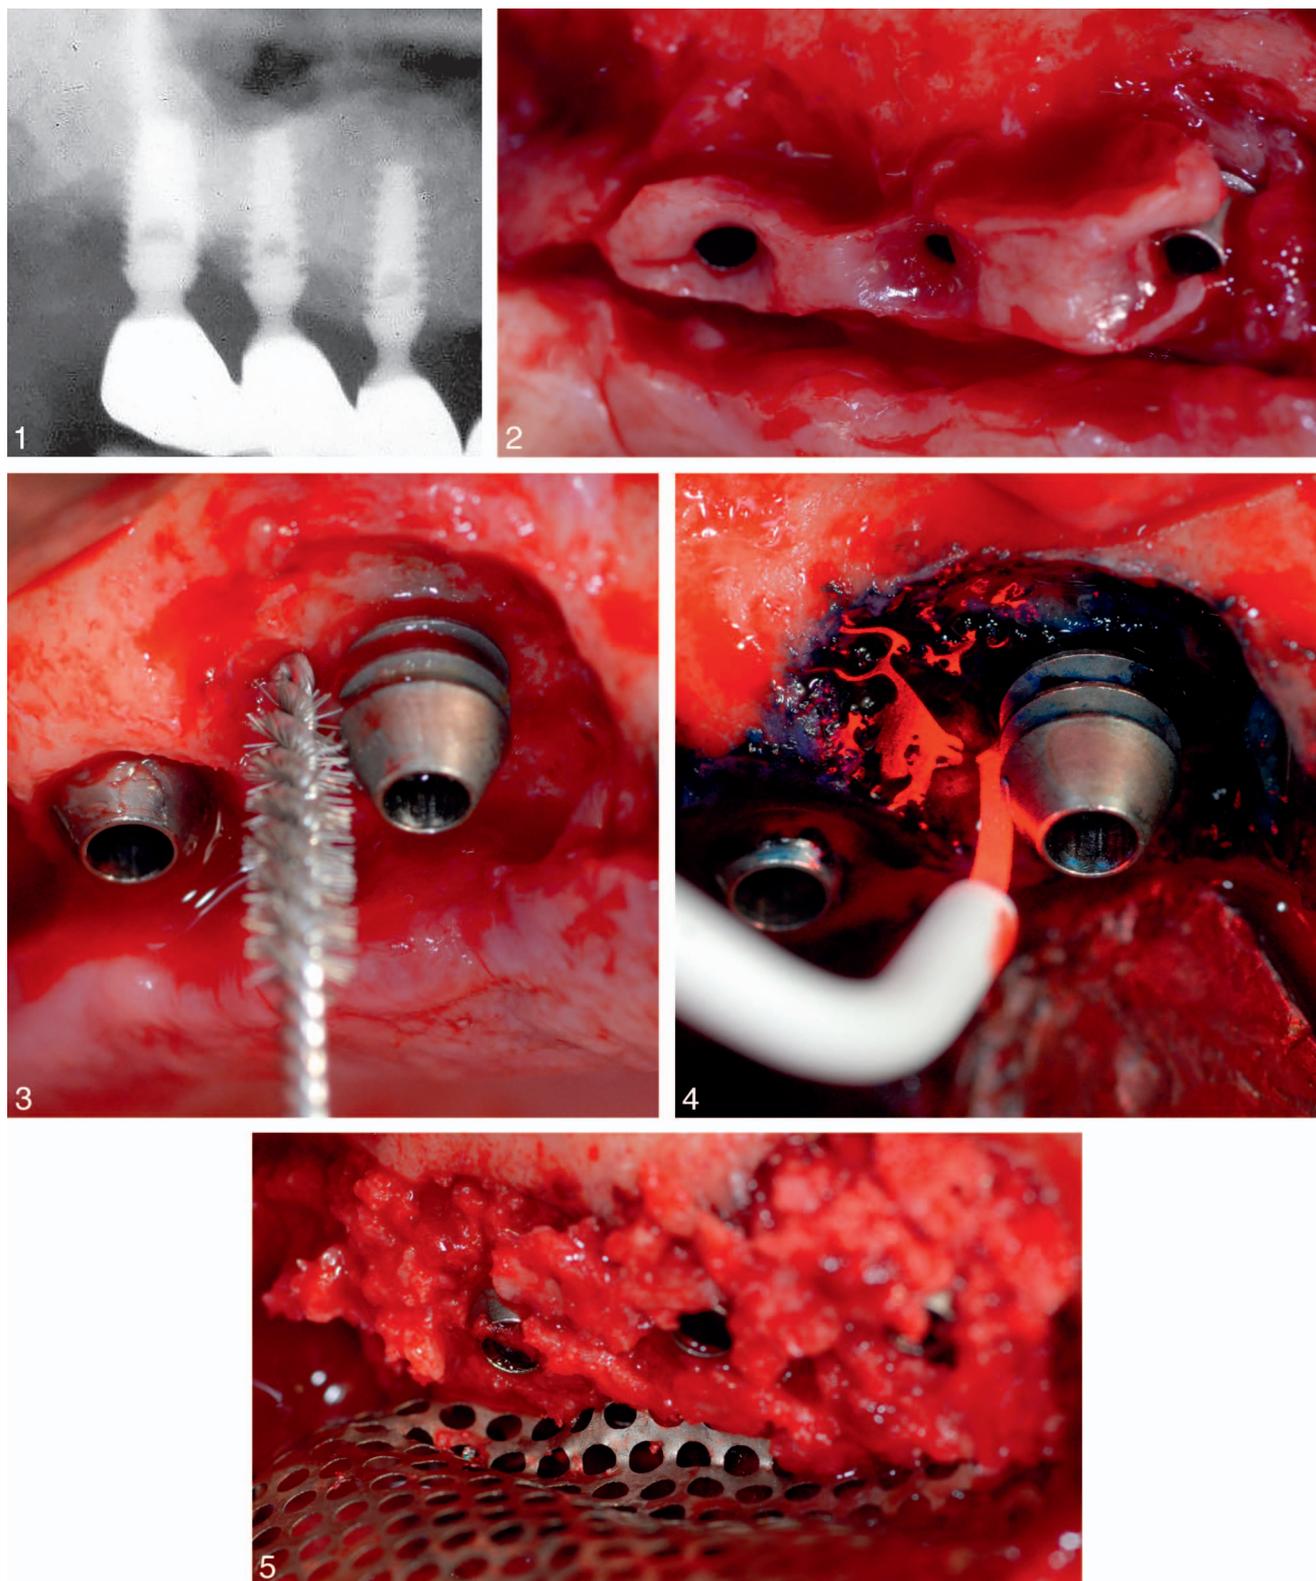
FIGURES 1–5. FIGURE 1. Preoperative orthopantomograph. Peri-implantitis defects are mainly visible on implants in position 2 and 4. **FIGURE 2.** Clinical view of the granulation tissue surrounding the implants in positions 2, 3, and 4. **FIGURE 3.** Mechanical decontamination of the implants' surfaces and biofilm disruption by means of titanium brushes. **FIGURE 4.** Antimicrobial photodynamic therapy consisting of phenothiazine chloride photo-activated by a low-level diode laser. **FIGURE 5.** Autogenous bone particles in direct contact with the decontaminated implants' surfaces.

September 2012. The patient could not be enrolled in a recall maintenance program due to temporary work relocation in another city for 2 years. The subject presented to the authors' attention in September 2014, citing bleeding during brushing and flossing associated with sporadic episodes of halitosis in the upper right quadrant. During the first clinical examination, bleeding on probing (BOP) and probing probe depth (PPD) ≥ 5 mm were registered circumferentially around the implants in positions 2 and 4. Bidimensional radiologic evaluation with a panoramic radiograph showed a peri-implant marginal bone loss ≥ 2 mm mesially and distally to the previously mentioned fixtures; therefore, the diagnosis of peri-implantitis was made (Figure 1). The patient was informed about the critical clinical condition of the implants, and a detailed description of the procedure was given. Subsequently, a signed informed consent was obtained. At baseline, the patient was instructed in the use of superfloss (Superfloss Oral-B, Procter & Gamble, Cincinnati, Ohio) and interdental brushes (TePe Munhygienprodukter AB, Malmo, Sweden). Nonsurgical therapy consisted of implant surface debridement under local anesthesia with articaine plus epinephrine 1:100 000 using carbon fiber curettes and curettage of the inflamed peri-implant soft tissue with sharp metal curettes. After mechanical debridement, the pockets around the implants were rinsed with 0.12% chlorhexidine solution (Dentosan, Recordati S.p.A., Milan, Italy). Two weeks later, aPDT was performed to minimize the local infection and to biostimulate the soft tissues with a specific setup (HELBO, Photodynamic Systems GmbH, Wels, Austria). A 0.1-mL solution of dye phenothiazine chloride (HELBO blue photosensitizer, Photodynamic Systems GmbH) was applied submucosally from the bottom to the top of the peri-implant pockets circumferentially around the implants and was left in situ for 3 minutes. Subsequently, the pockets were rinsed for 1 minute with 3% hydrogen peroxide to remove the photosensitizer in excess. A hand-held diode laser with a wavelength of 660 nm and a power density of 100 mW (HELBO TheraLite Laser, Photodynamic Systems GmbH) equipped with a dedicated probe (HELBO 3D Pocket Probe, Photodynamic Systems GmbH) was used to activate the remaining photosensitizer circumferentially at 6 aspects per implant (mesiobuccal, midbuccal, distobuccal, and respective palatal sites) for 10 seconds each. Adjunctive aPDT was repeated 1 week later according to the manufacturers' instructions to reduce the bacterial count and gingival inflammation. The surgical procedure was carried out after a healing period of 2 weeks. The patient was asked to rinse preoperatively with a 0.2% chlorhexidine solution before receiving perioral skin disinfection with benzalkonium chloride. An antibiotic therapy consisting of 2 g amoxicillin clavulanate was administered 1 hour before surgery. Local anesthesia was induced with articaine and epinephrine 1:100 000. Then, 4 mg dexamethasone was injected into the muscles around the surgical site to reduce postoperative swelling. Full-thickness flaps were reflected by means of para-marginal incisions (Figure 2). Subsequently, all granulation tissue was completely removed from the defect area, and the implant surfaces were thoroughly debrided and instrumented using titanium curettes and rotary titanium brushes (Ti-Brush, Straumann, Basel, Switzerland) fixed on a surgical handpiece, oscillating in a clockwise/counter-clockwise direction at low speed (800 rpm for

1 minute per surface) under irrigation with sterile saline solution (NaCl) to remove the bacterial biofilm (Figure 3). A copious irrigation with sterile physiologic saline was then performed to cleanse the surgical area. Clinically, the defects were mainly crater-like, characterized by a consistent horizontal bone loss, identifiable as a supra-alveolar exposure of the implants' surface. At this point, aPDT was accomplished with the same modalities adopted during the nonsurgical intervention; that is, the photosensitizer was applied on the implant surfaces and surrounding tissues, left in place for 3 minutes, rinsed for 1 minute with 3% H₂O₂, and photo-activated at 6 sites per implant for 10 seconds each (Figure 4). Autogenous bone chips were then harvested from the zygomatic process of the maxilla and the tuber maxillae of the same side with a bone collector (Safescraper TWIST, Meta, Reggio Emilia, Italy) and trephine burs. Perforations into the marrow space were performed using small round surgical burs to facilitate vascularization of the graft and cell colonization from the bone marrow. A 0.2-mm-thick titanium mesh (KLS Martin, Tuttlingen, Germany) was trimmed and adapted to the surgical defect to create a proper bone contour. The Ti-mesh was shaped, avoiding sharp edges, to prevent soft tissues dehiscence or exposure. Before grafting the defects, plastic caps were inserted into the implants' connection to prevent bone ingrowth. Both the intrabony and the supracrestal part of the peri-implant defects were grafted. Autogenous bone particles were placed in direct contact with the implants' surfaces (Figure 5), and a mixture of autogenous bone chips and DBBM (Bio-Oss, Geistlich, Wolhusen, Switzerland) in a 70:30 ratio was positioned in a way as to homogeneously recreate the alveolar process architecture. The titanium mesh was then placed over the graft and fixed to the palatal and buccal bony walls using cortical screws on each side to prevent any micromovement (Figure 6). A resorbable collagen membrane (Biogide, Geistlich) was finally applied over the titanium mesh to exclude the epithelial cells ingrowth (Figure 7). Periosteal horizontal releasing incisions followed by upper traction were performed to mobilize the buccal flap and obtain a passive closure. A first intention healing of the surgical wound was accomplished with horizontal mattress and single stitches using 3-0 Vicryl and 4-0 silk (Ethicon Inc, Somerville, NJ) sutures. The antibiotic therapy consisted of 1 g amoxicillin clavulanate starting the day before the surgery twice daily for 6 days. Anti-inflammatory and analgesic therapy was prescribed (ibuprofen 600 mg, 3 times daily) during the first 2 days and according to the patient's individual needs thereafter. A soft cold diet was suggested for the first 24 hours after the surgery, together with the application of ice packs for 10 minutes every 30 minutes for the first 4 hours. The patient was also instructed to rinse 3 times daily with 0.2% chlorhexidine mouthwash rinse solution for 1 minute starting the day after the surgery until suture removal. The sutures were removed after 12 days. During the 6-month healing period, no complications occurred (Figure 8). Local anesthesia was induced, and a horizontal incision was performed to reflect a full-thickness flap to uncover and remove the titanium mesh (Figure 9). No clinical signs of inflammation or infection were recorded, and the grid was firmly attached to the newly formed bone underneath. New bone formation was observed filling the entire space under the

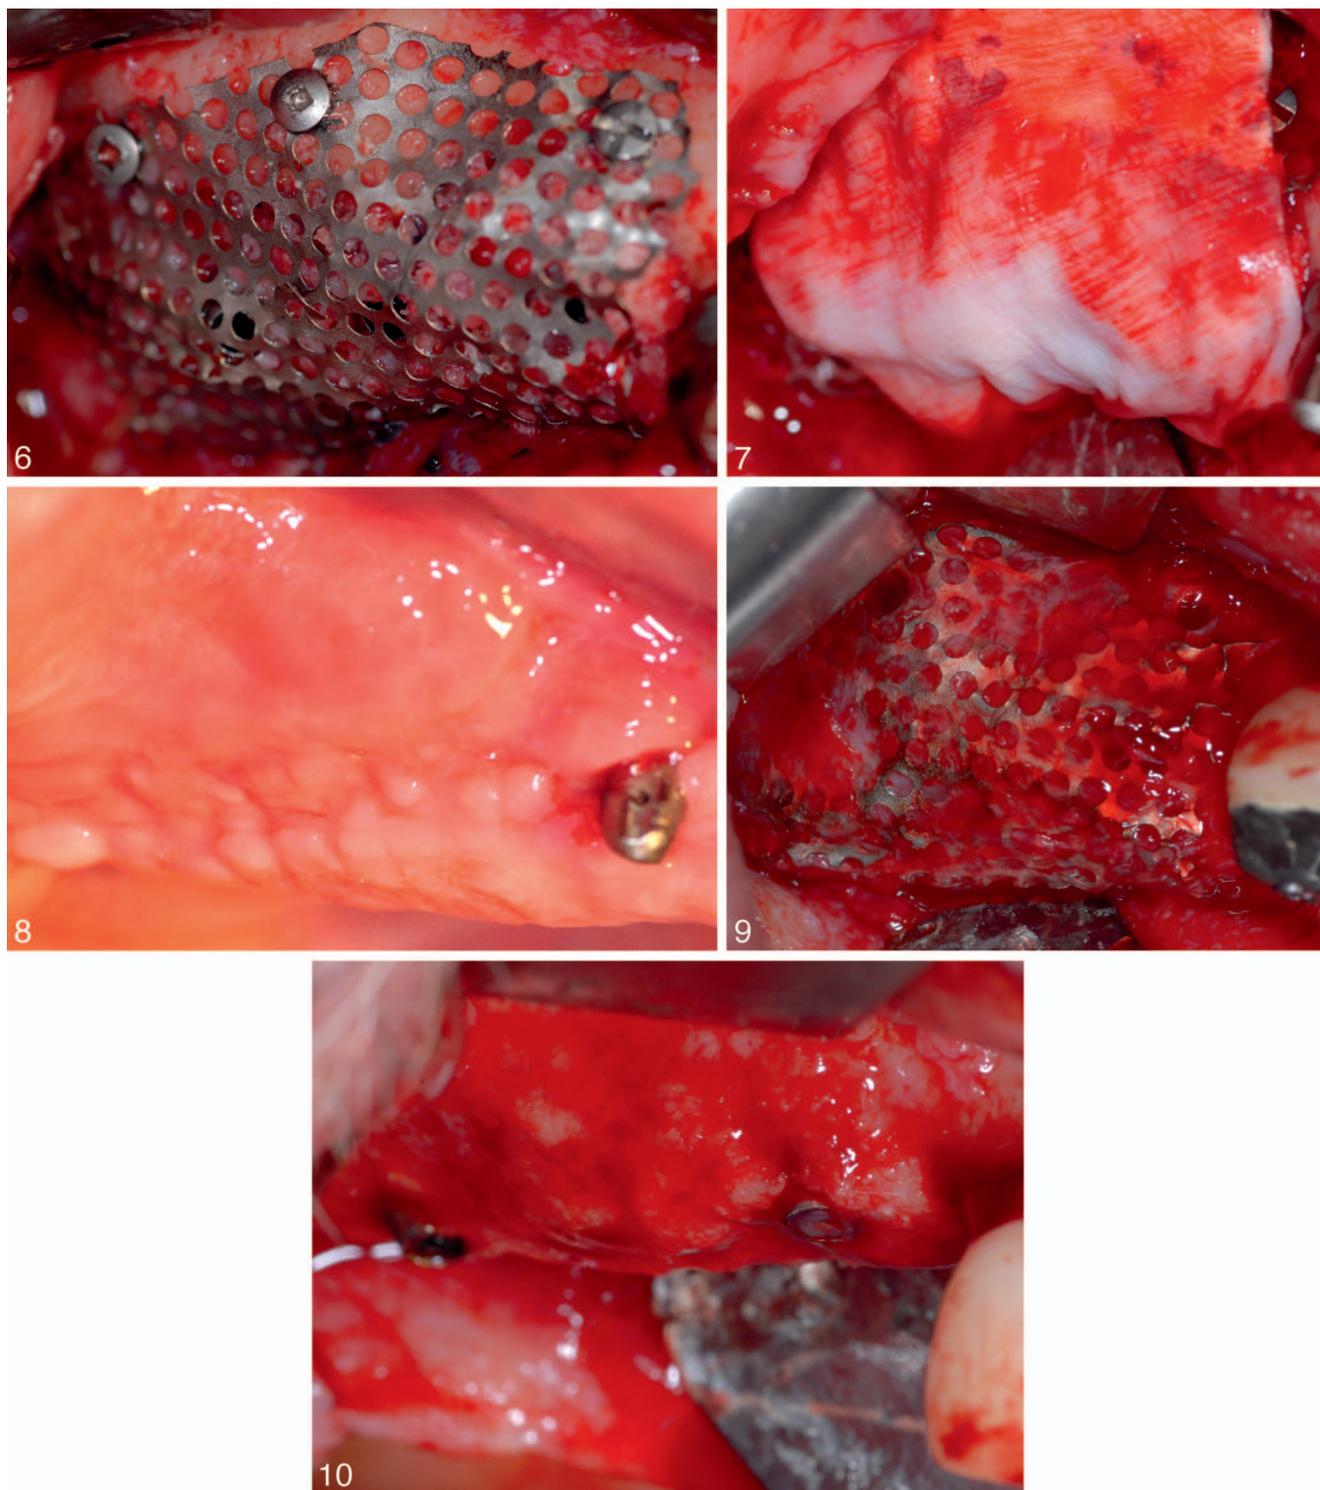
FIGURES 6–10. **FIGURE 6.** Titanium mesh secured in the proper position with osteosynthesis screws. **FIGURE 7.** A nonresorbable membrane is placed above the titanium mesh to prevent the soft tissue ingrowth. **FIGURE 8.** Clinical view of the surgical wound after a 6-month healing period. A first intention sealing has been accomplished. **FIGURE 9.** Re-entry surgery after 6 months of healing time. **FIGURE 10.** Clinical view of the previously affected implants' sites. Bone overgrowth is clearly visible at the top of the implant head in position 3.

titanium mesh. The combined defects, mainly characterized by a noncontained component, were completely eliminated. The previously exposed threads were completely covered and, in the case of implant 3, the cover screw was overwhelmed by the

regenerated bone (Figure 10). The newly formed tissue was well vascularized and indistinguishable from the host bone (Figure 11). Healing abutments were then screwed to the implant, and a nonsubmerged approach was performed. After 3

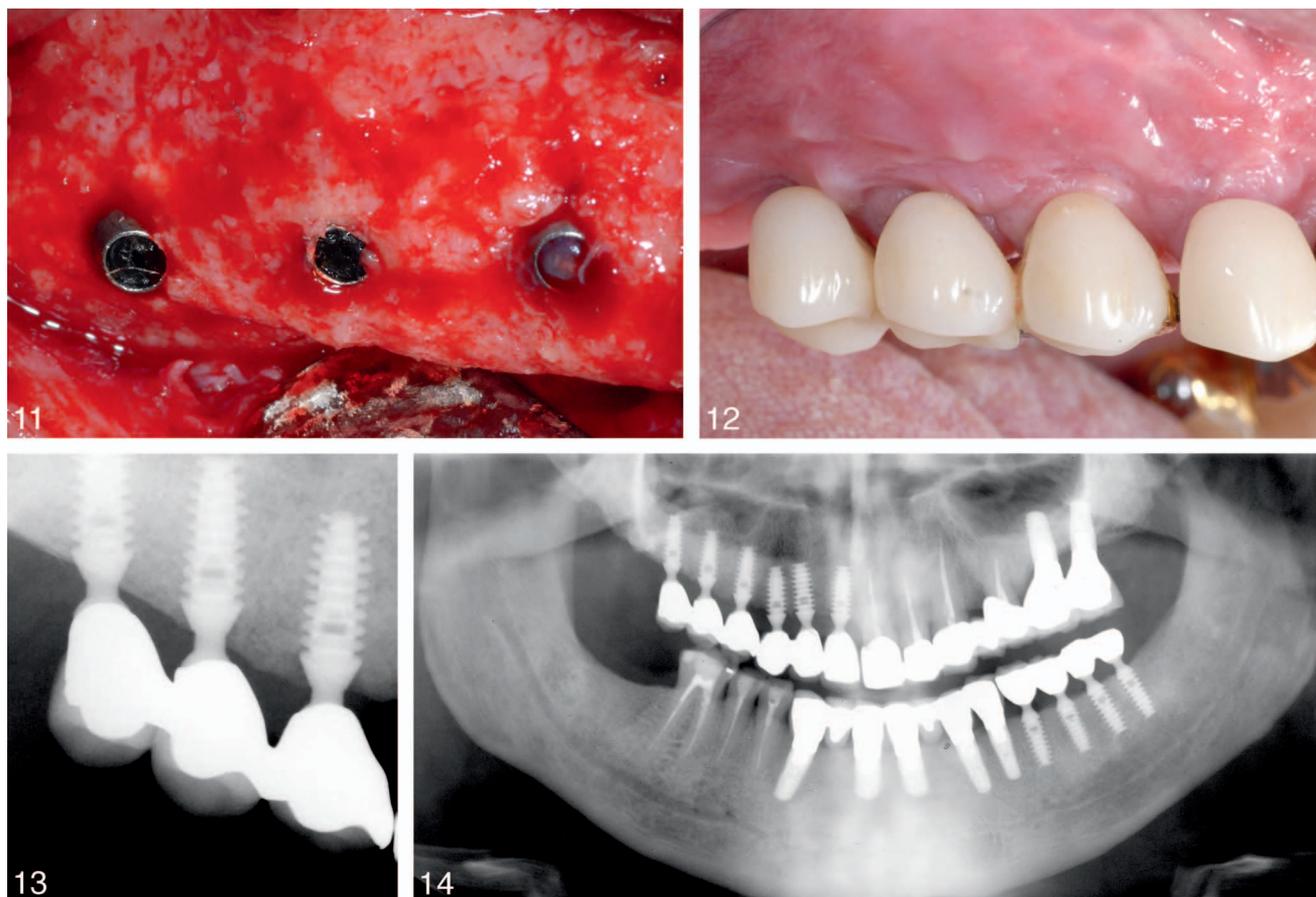
FIGURES 11–14. **FIGURE 11.** Clinical view of the newly formed bone, well integrated and indistinguishable with respect to the surrounding hard tissue. **FIGURE 12.** One-year recall from the connection of the definitive restoration. Wide spaces have been left between the prosthetic crowns, allowing the patient to properly perform ideal oral hygiene procedures. No signs of bleeding on probing or pathologic probing depths have been recorded. **FIGURE 13.** One-year peri-apical radiograph demonstrating the stability of the mesial and distal bone levels of all the implants. **FIGURE 14.** One-year orthopantomograph.

weeks, definitive abutments were repositioned to the corresponding implants, and the final prosthesis was delivered (Figure 12). The patient was finally placed on an individually tailored professional maintenance program. After 1 year of follow-up, the implants appeared clinically stable, with no BOP and PPDs ≤ 3 mm. The radiographic examination, consisting in a periapical radiograph (Figure 13) and orthopantomograph (Figure 14) acquired 1 year after the prosthetic connection, confirmed a substantial stability of bone graft without mesial and distal pathologic peri-implant bone loss.
